# Intel® 82571EB/82572EI Ethernet Controller

Specification Update

*July 2010*  
*Revision 6.3*

**322206US**

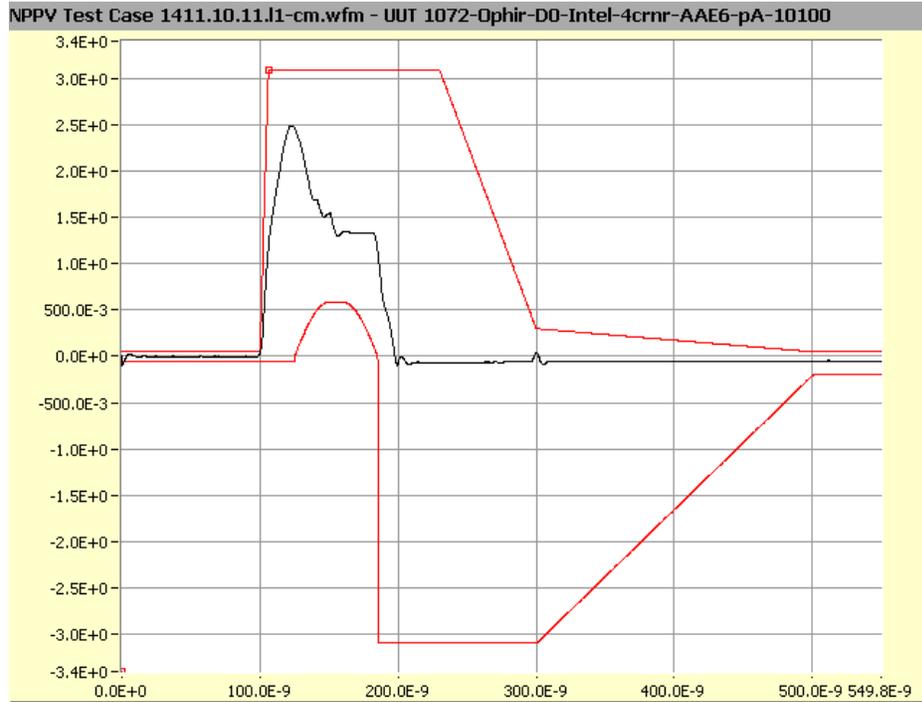
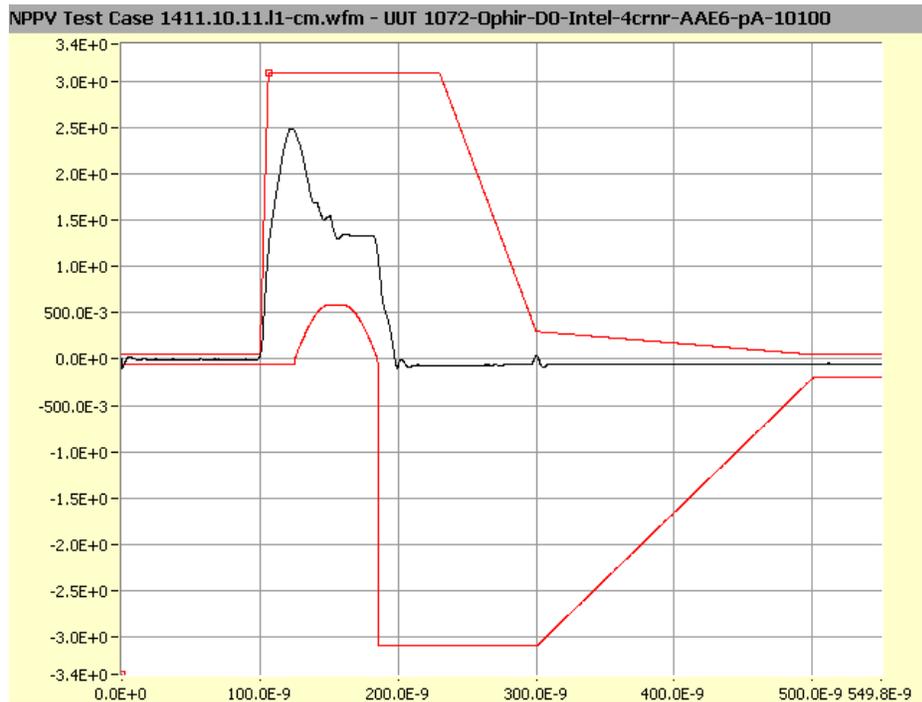
## 27. 10base-T Link Pulse Hits the Template Mask Due to Voltage Ripple/Glitch

Problem: The 10base-T link pulse touches the template due to voltage ripple/glitch.

Implication: Compliance with the specification is not complete, however, there is no effect at system level.

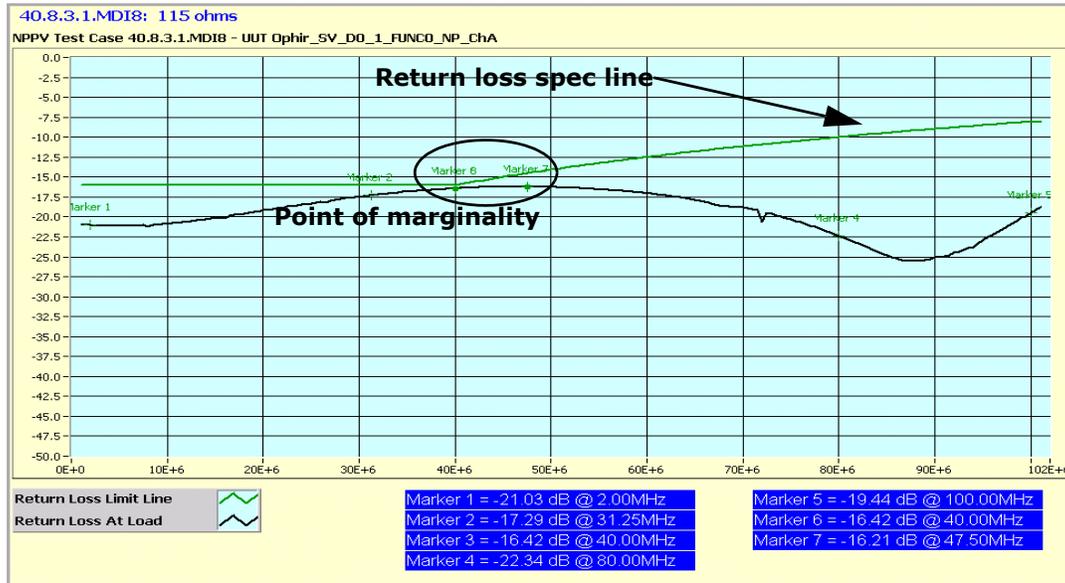
Clarification: Return loss for 115 ohm load is marginal (Gigabit IEEE specification Section 40.8.3.1) near the frequency of 40MHz. Return loss is acceptable throughout the rest of the frequency spectrum and conforms to the 10Base-T and 100Base-TX specification limits.

IEEE conformance is marginal. There is no impact on system-level performance.
