Intel® 82571EB/82572EI Ethernet Controller

Specification Update

*December 2008
Revision 6.0*

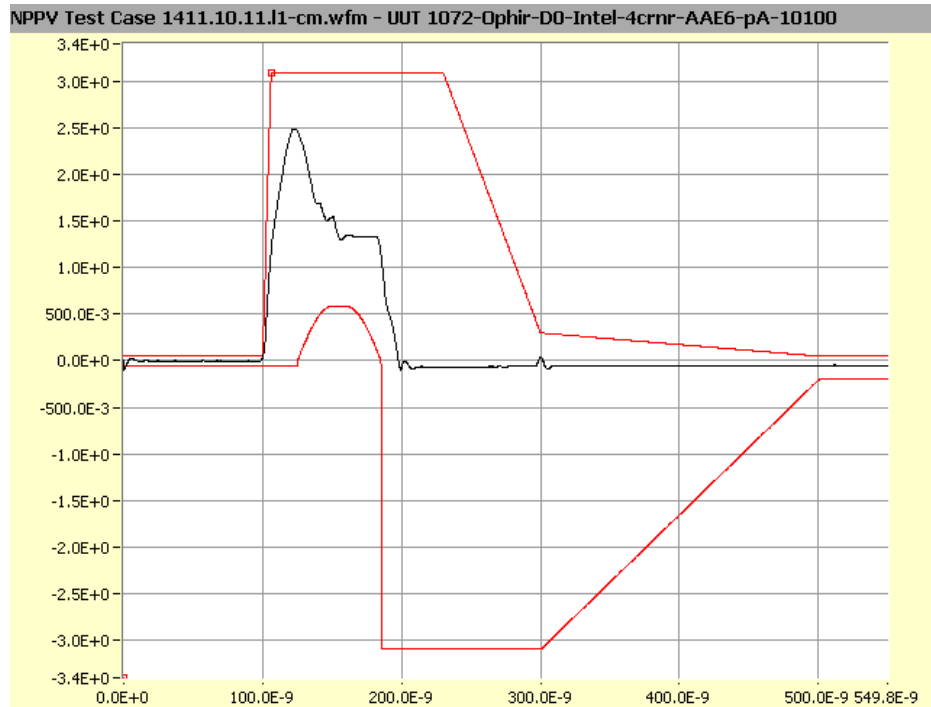
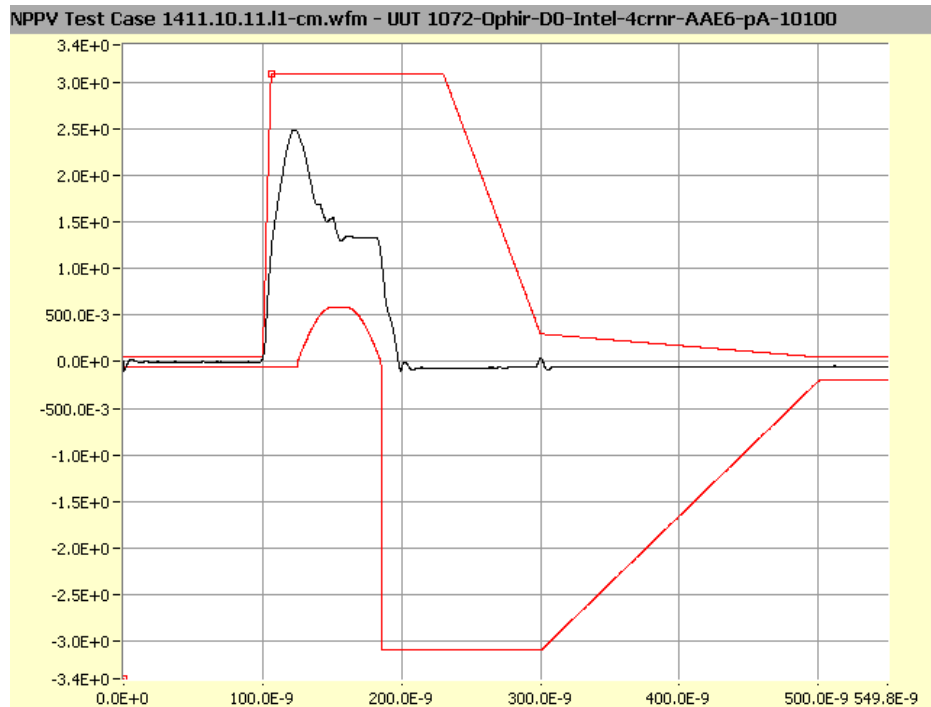
27. 10base-T Link Pulse Hits the Template Mask Due to Voltage Ripple/Glitch

Problem: The 10base-T link pulse touches the template due to voltage ripple/glitch.

Implication: Compliance with the specification is not complete, however, there is no effect at system level.

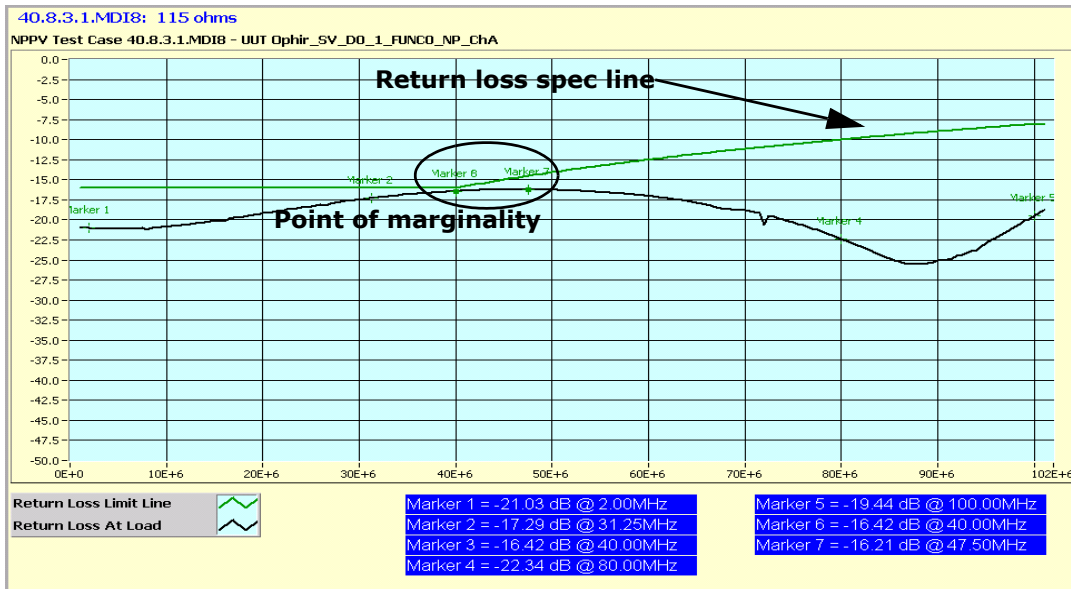
4. MDI Return Loss Is Marginal Near 40MHz at 115ohm Load.

Clarification: Return loss for 115 ohm load is marginal (Gigabit IEEE specification Section 40.8.3.1) near the frequency of 40MHz. Return loss is acceptable throughout the rest of the frequency spectrum and conforms to the 10Base-T and 100Base-TX specification limits. IEEE conformance is marginal. There is no impact on system-level performance.
