# LXT971A/972A PHY Transceivers

## Specification Update

Order Number: [249354-005](#)

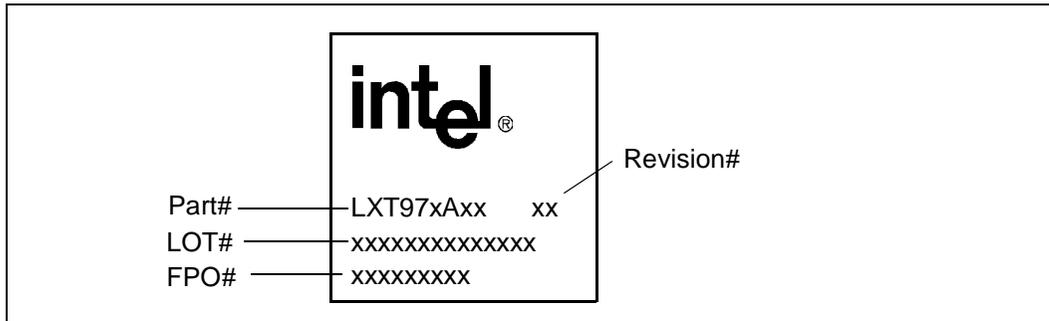
## Markings

The silicon stepping in the LXT971A/972A Data Sheet is referred to as “Manufacturer’s Revision Number.” The silicon stepping number may be read by software from Register 3, bits 3:0 in the LXT971A/972A7 transceivers.

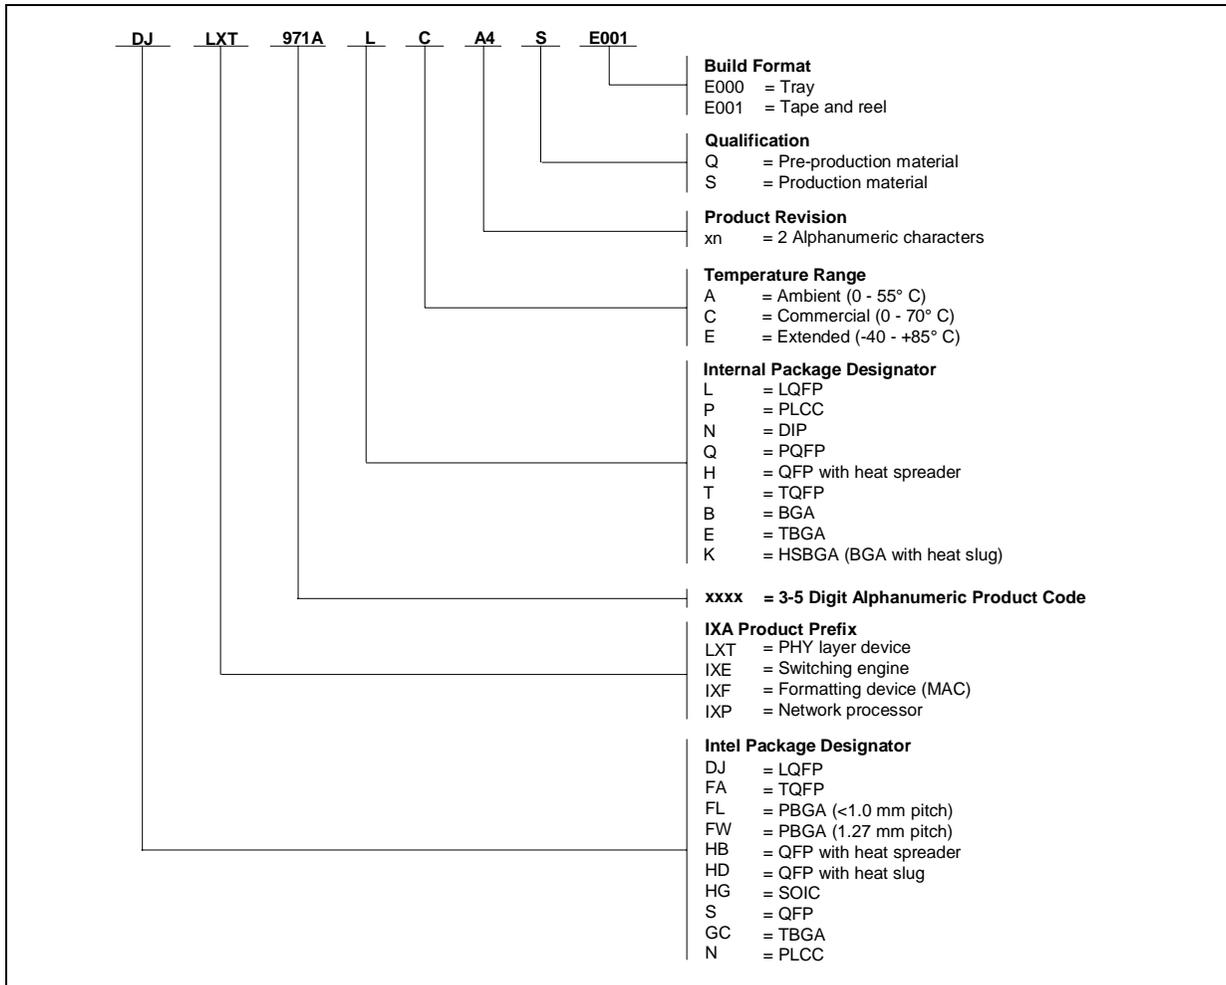
**Figure 1. Ordering Information - Sample**

Number	Revision	Qualification	Tray MM	Tape & Reel MM
DJLXT971ALC.A4	A4	S	834105	834916
DJLXT971ALE.A4	A4	S	835676	835791
FLLXT971ABC.A4	A4	S	834103	834926
FLLXT971ABE.A4	A4	S	834104	835080
DJLXT972ALC.A4	A4	S	834109	834917
